The Mount Conservation Area

Conservation Area Appraisal

Draft V4.0

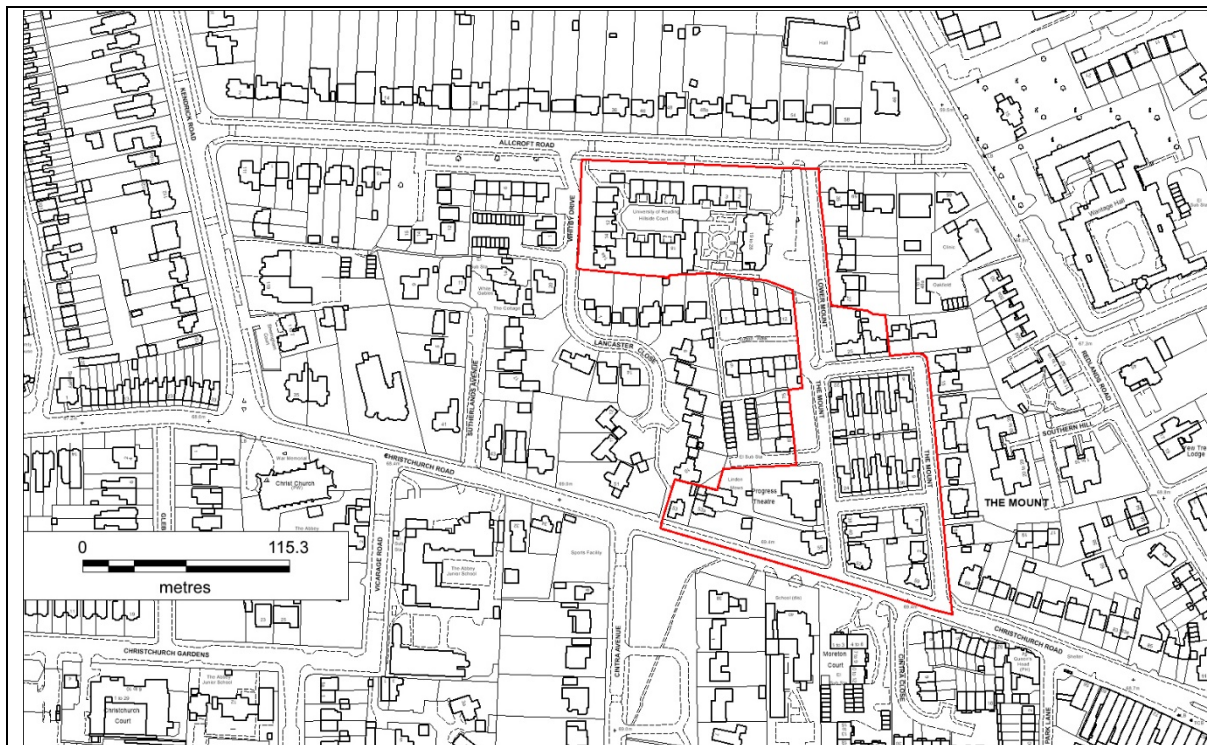
Map 1 Existing Conservation Area Boundary

Figure 1 The existing boundary is marked by a solid line

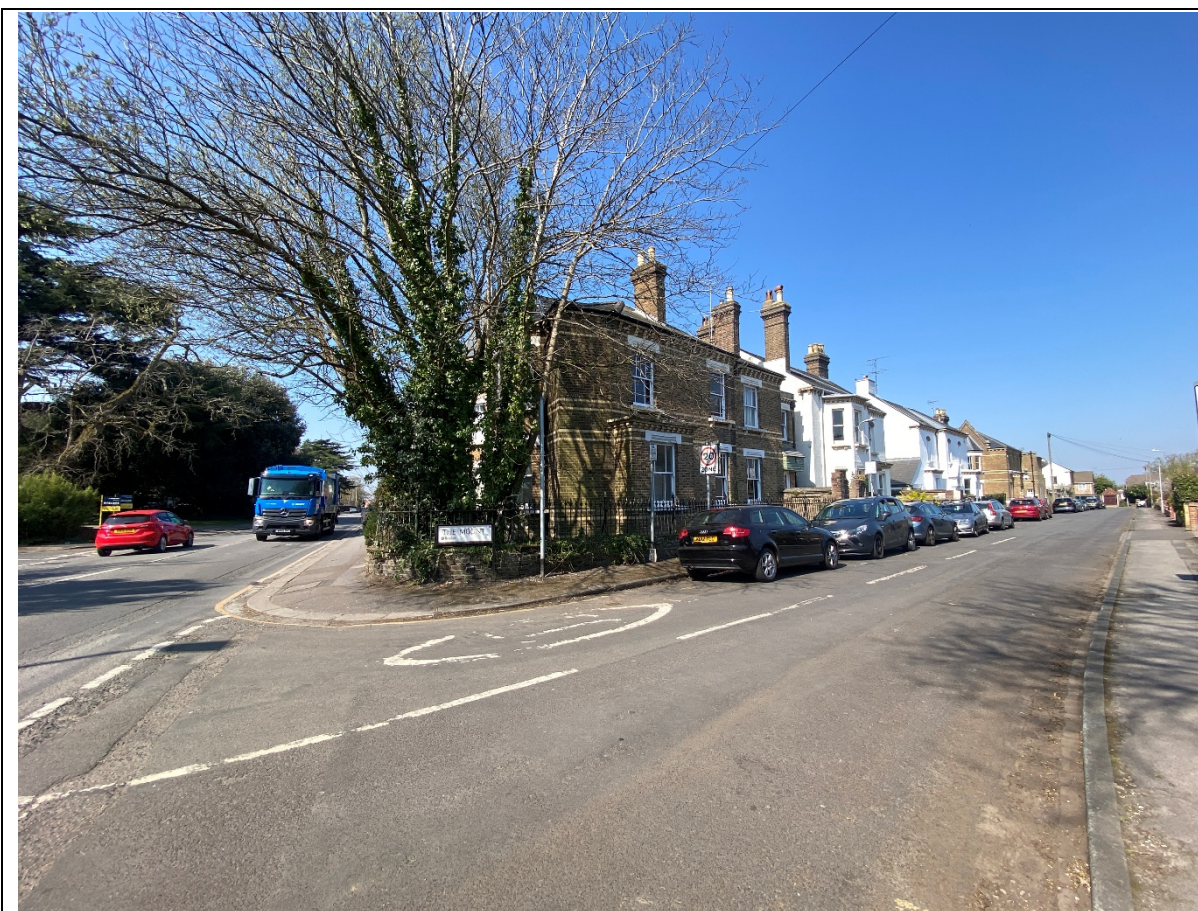
Map 3 Views into The Mount CA

Figure 5 Views into the conservation area shown with blue arrows

Views into the area are north-south along the grid between Christchurch Road (to the south boundary) and Allcroft Road (to the north boundary). The view looking north from the south is from the higher vantage point in the conservation area. The roads forming the north-south/west-west grid are all called 'The Mount'

- Looking north along 'The Mount' (east) road – View 2
- Looking north along 'The Mount' (west) road – View 1
- Looking south from the lower position of Allcroft Road along Lower Mount which rises up toward the Mount – View 3

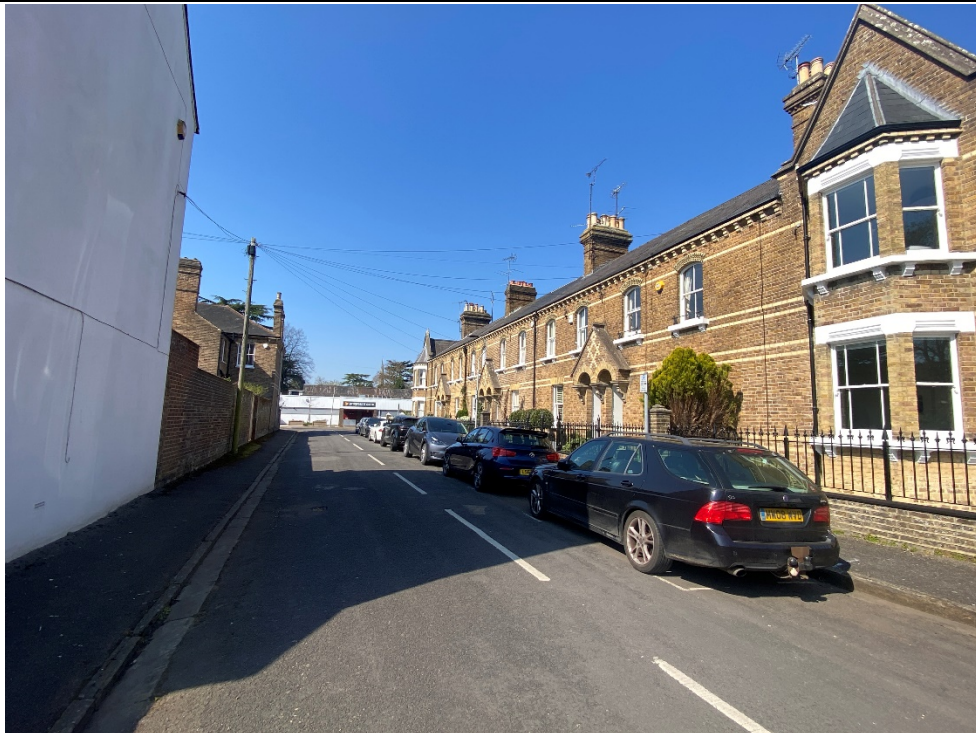
*Figure 7 View 4 – view west towards the Progress Theatre along The Mount (south)
(image Claire Truman)*

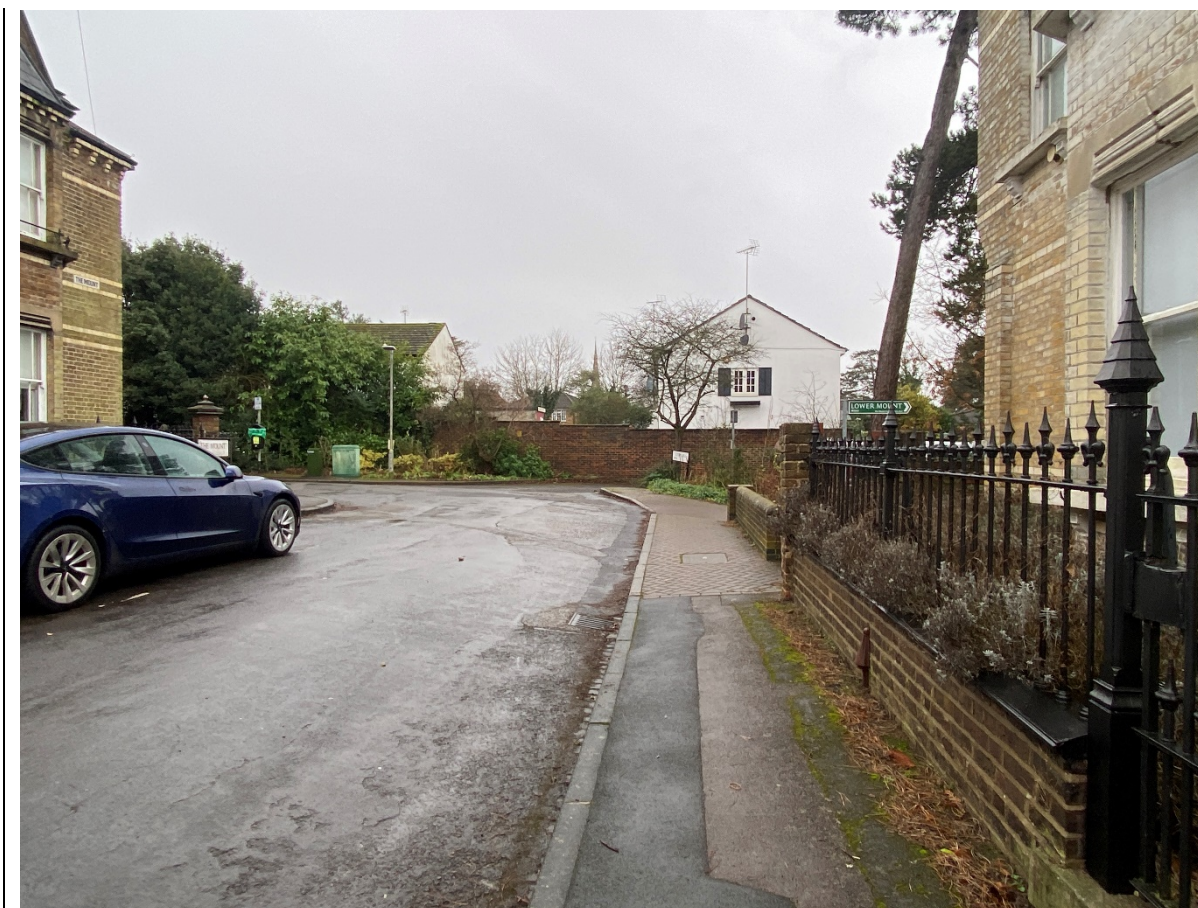
Map 5 Views out of The Mount CA

Figure 8 Views out of The Mount CA shown with red arrows

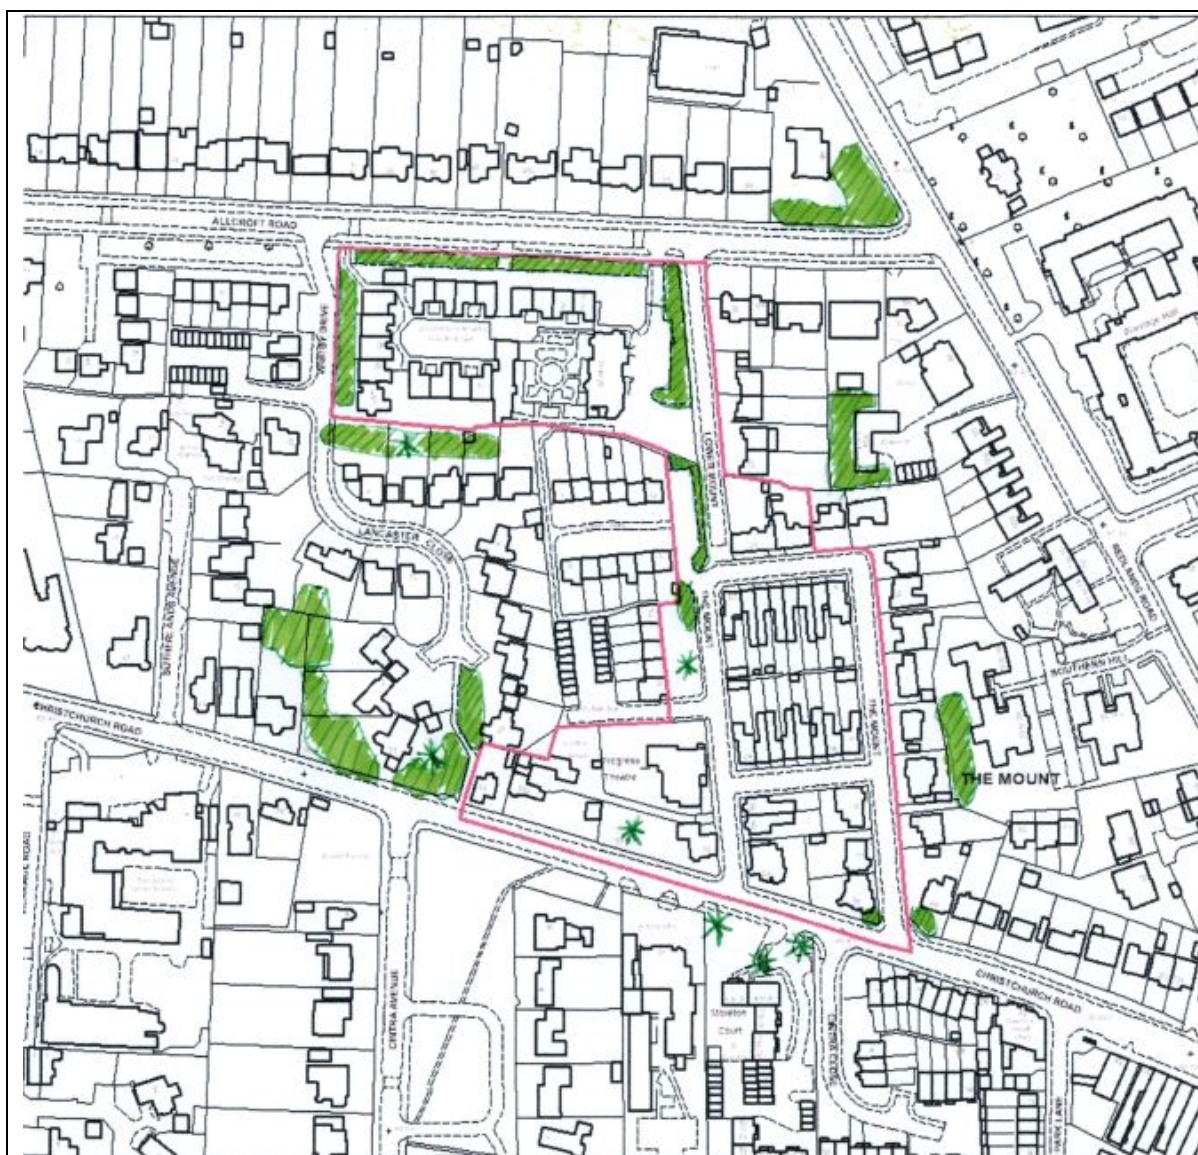
Map 6 Trees and green spaces within the conservation area

Figure 10 Trees (with TPO trees), other significant trees and green spaces within and adjacent to the CA

The CA generally comprises mature trees, and although these tend to have small gardens (The Mount and Christchurch Road) and/or little garden space around them, there is important tree cover on the Christchurch Road and “Hillside Court” frontages, which gives a general verdant feel to the area of buildings and trees in harmony. Street trees exist to the west side of The Mount/Lower Mount in front of Sutton Walk which generally make a significant contribution to this urban conservation area’s special character and sense of identity (see Appendix 6). Tree cover immediately adjacent to the CA (some protected by Tree Preservation Orders) also contribute to the setting of the CA, and in particular those in the adjacent Christchurch Conservation Area and Redlands Conservation Area. Trees therefore make a significant contribution to the CA’s special character and sense of identity. Significant tree groups are shown on the Appraisal Map at Appendix 1.

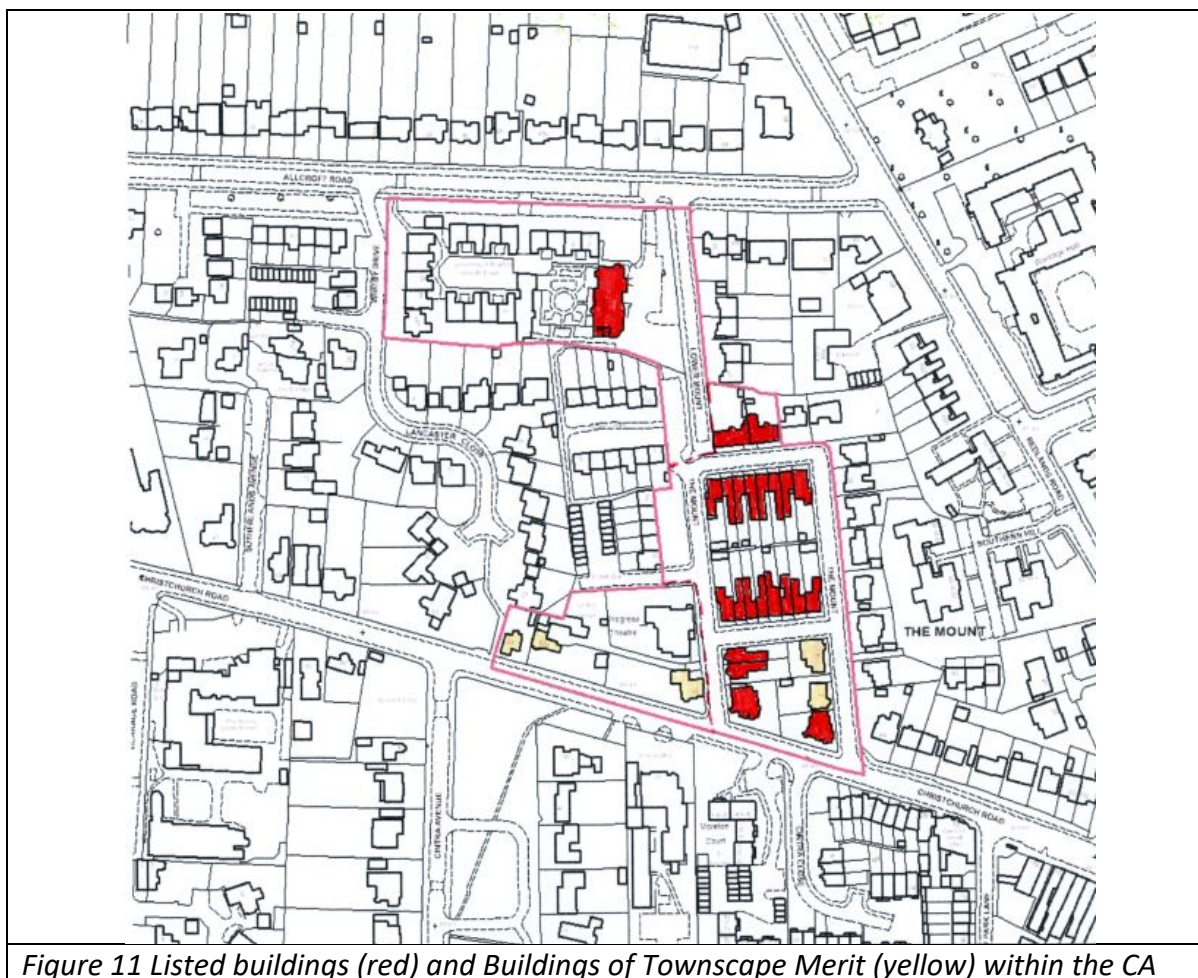
Map 7 Listed Buildings and Buildings of Townscape Merit

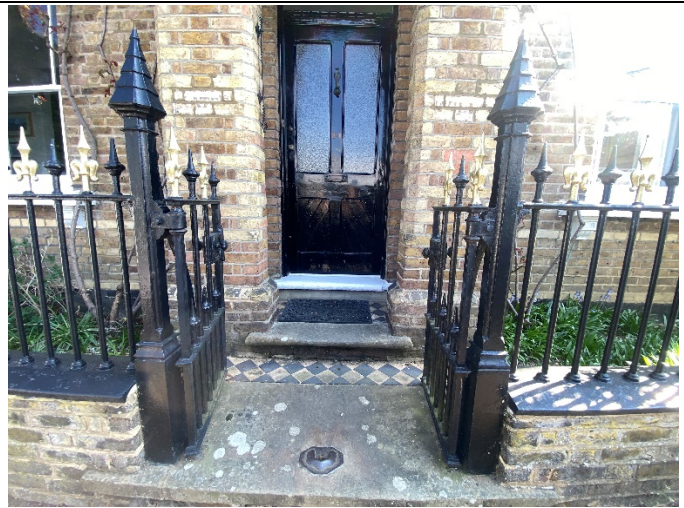
Figure 13 Double leaf gate at No. 24; and opposing detached houses No.s 22 and 8.

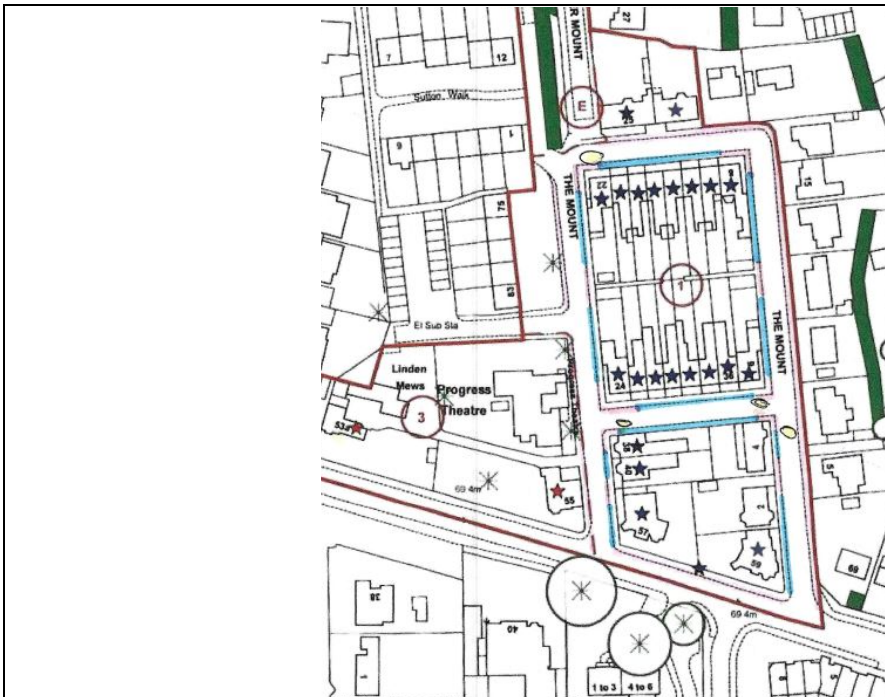
Figure 14 Diagram of location of stone (blue) and concrete (pink) kerbs, and original ironworks (circles) at The Mount (compiled by local resident)

Road and footway surfaces are a mixture of finishes: the original kerbs and channels are a distinctive local detail of the stone 'Caithness Flagstone Series' of stone – only found elsewhere in Reading in Fatherson Road (adjacent to the Eldon Road Conservation Area); iron drain covers are partially retained and were manufactured in nearby Katesgrove; the surfaces are tarmac.

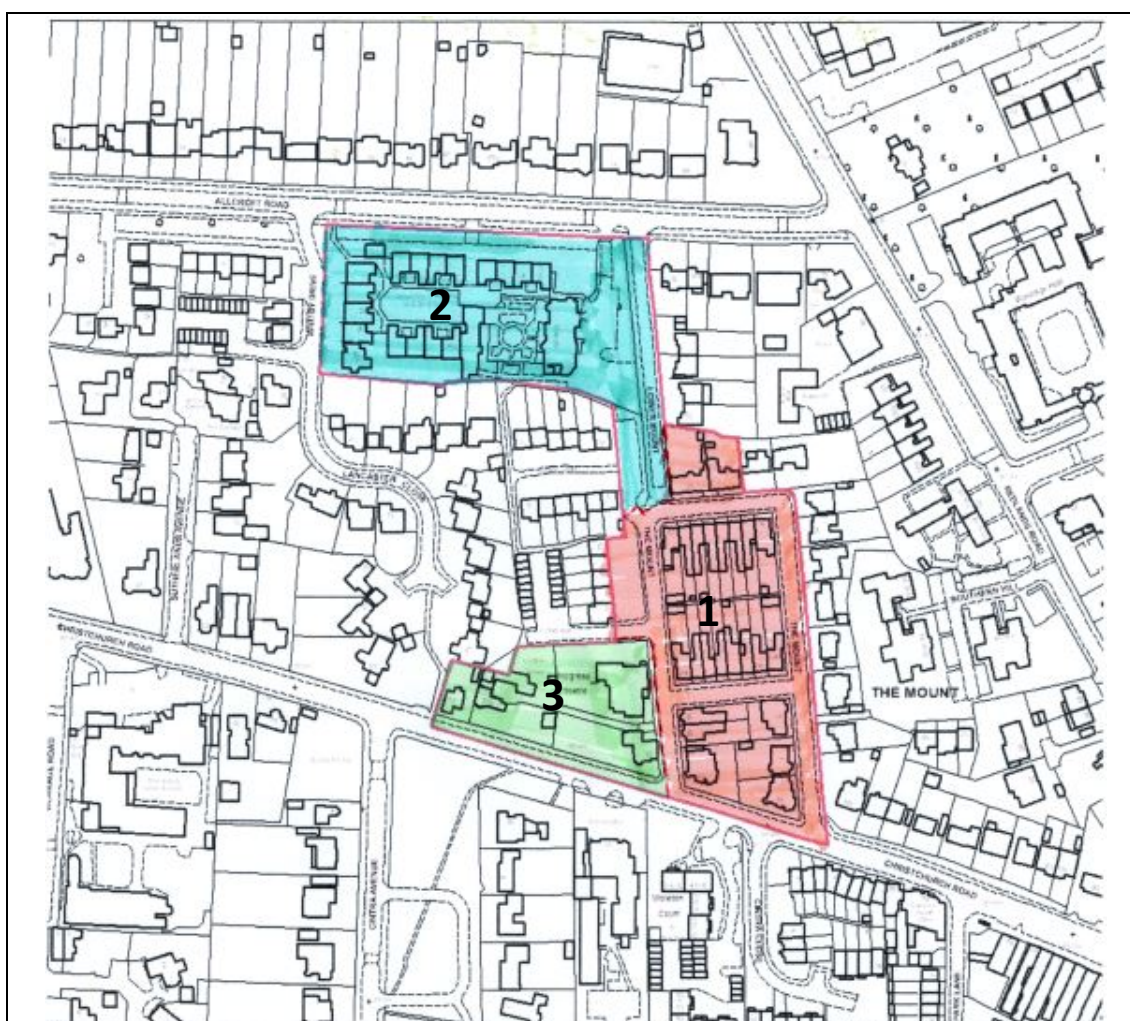
Map 8 Character Areas

Figure 15 Character Areas 1-3

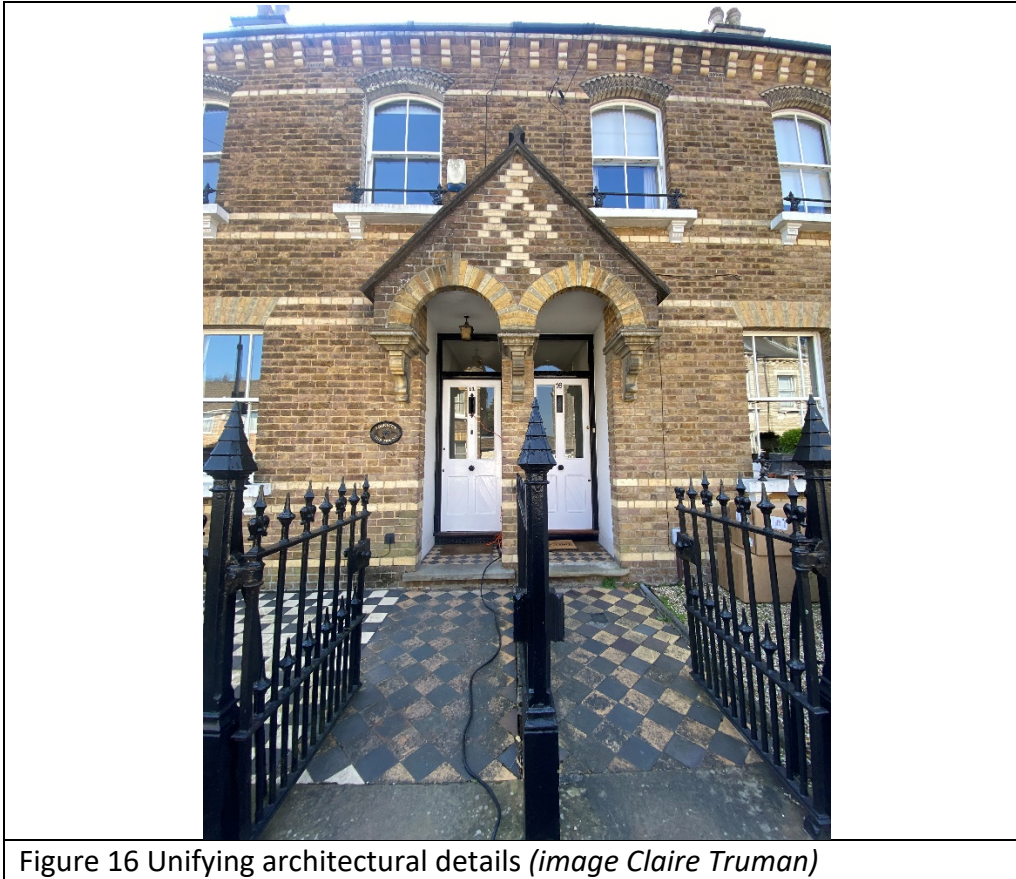
Figure 16 Unifying architectural details (*image Claire Truman*)

- Slate roofs: some with fish scale courses (e.g. at No. 57 and 57A The Mount), some with geometric shaped courses (e.g. at Uplands and 23 The Mount)
- the inclusion of turret designs at key corner locations

- prominent brick chimneys with dogtooth brick course details
- Fleur-de-lys railing design on a low brick wall.

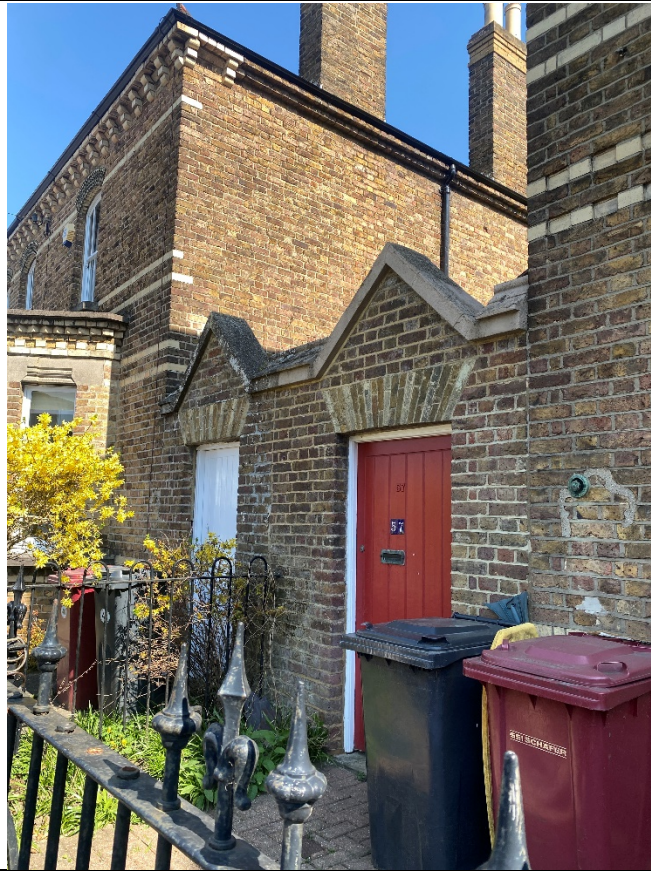
- Unifying walls between properties – such as the enclosing wall with paired garden access between No.s 57 and 40 (refer to Figure 18) illustrate the holistic urban design.
- The consistent brick band details are located at the same height across the north and south 'blocks' despite the fall in gradient north-south along the road, and internal level changes between rooms and between properties. In particular the band detail carried through between No.6 and No.8 (refer to Figure 18) remains consistent yet the internal floor levels of the two properties differ in their relationship with the banding.
- The unifying architectural details, as listed on the previous page.

Figure 17 Unifying urban design (*image Claire Truman*)

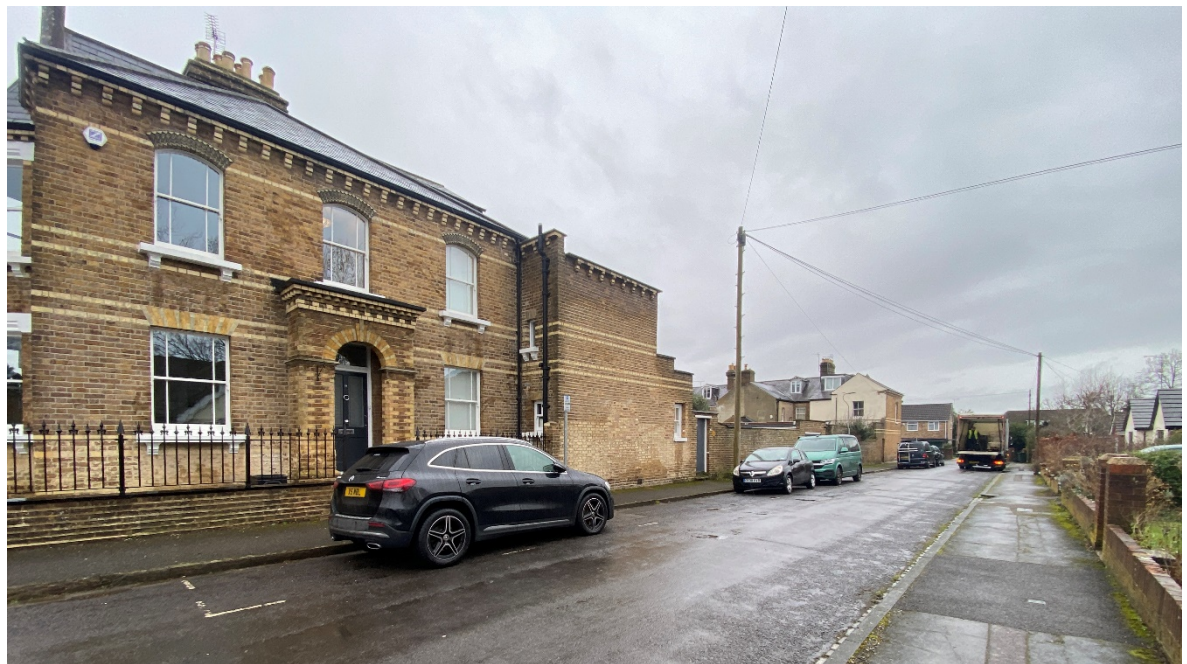
Figure 18 Unifying yellow brick bands between properties in the north-south road directions (*image Claire Truman*)

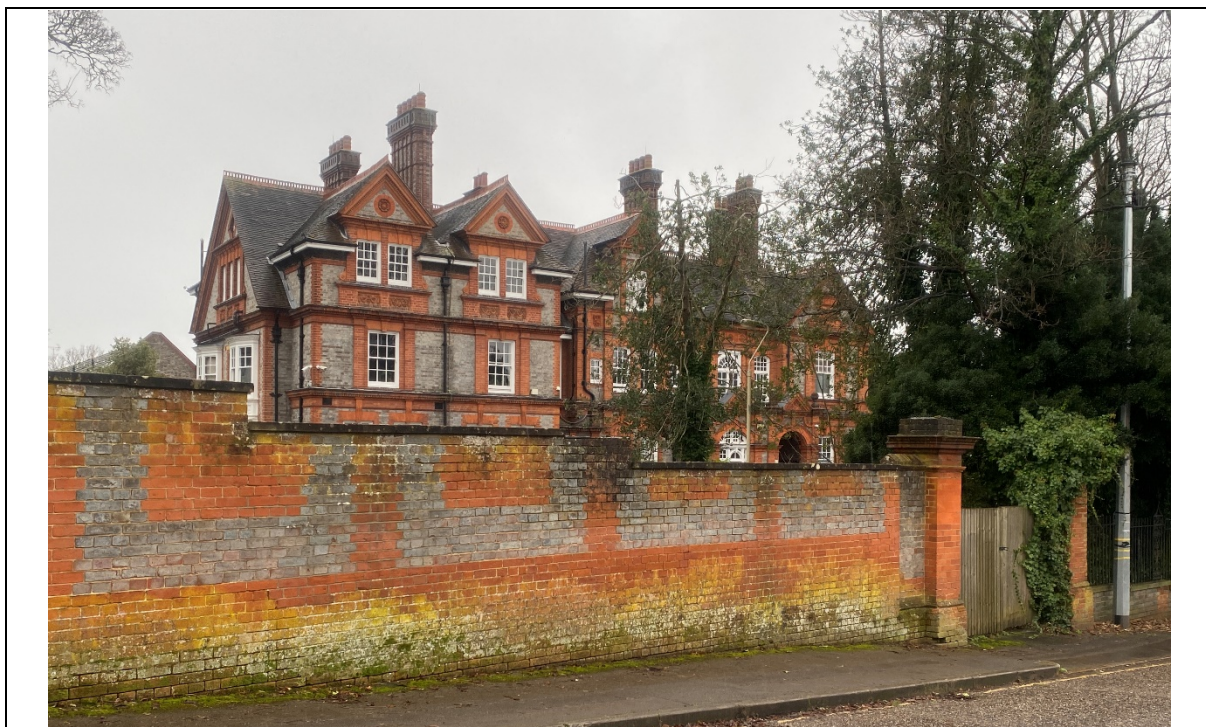
Hillside, to the north of The Mount, is a good example of a large Victorian detached house, which also retains its original walls and railings. It is dated 1880 by Morris and Stallwood for W I Palmer of Huntley & Palmers, and was extended and dated 1898 by the same Stallwood alone for Leonard Goodhart Sutton (1863-1932), grandson of John Sutton founder of Suttons Seeds, moved to Hillside after the death of W I Palmer. It is built of grey brick with extensive red brick and terra cotta dressings, slate roofs and red tile cresting. The listing describes it as “one of the most opulent buildings of this period in Reading, which has a rich diversity of late C19 housing. Morris and Stallwood were prolific and accomplished local architects, well-tuned to the tastes and trends in public and private building, suited to a wealthy client wishing to invest in a building of the highest quality”. The building is now owned by Turner Property and subdivided into flats. Although the grounds have been built over in part, the house retains its entrance drive, gates and railings and some of its garden, giving it its original sense of scale space and context.

The gate piers, walls, gates and railings form two sides of the boundary to Hillside to Allcroft Road and Lower Mount. These date from circa 1880-1900 and are valuable in putting the house in context, and are listed separately (List Entry Number 1392868). A pair of brick piers with an enriched terracotta frieze of rosettes are located either side of the main driveway, inscribed with ‘Hillside’. At the entrance off Lower Mount two less ornate paired brick gatepiers remain: the original timber gates are currently in storage at Hillside awaiting repair and reinstatement.

Figure 19 View of the east elevation of Hillside from Lower Mount (*image Claire Truman*)

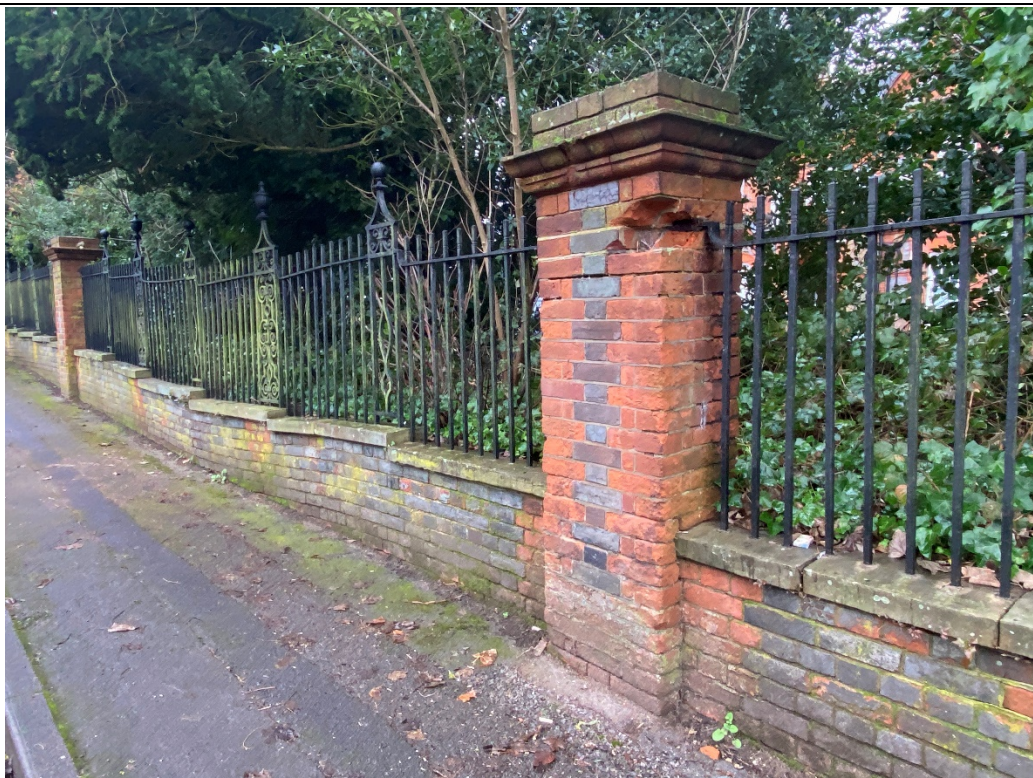
Figure 20 The brick piers and railings to Hillside are falling into disrepair – view along Lower Mount (*image Claire Truman*)

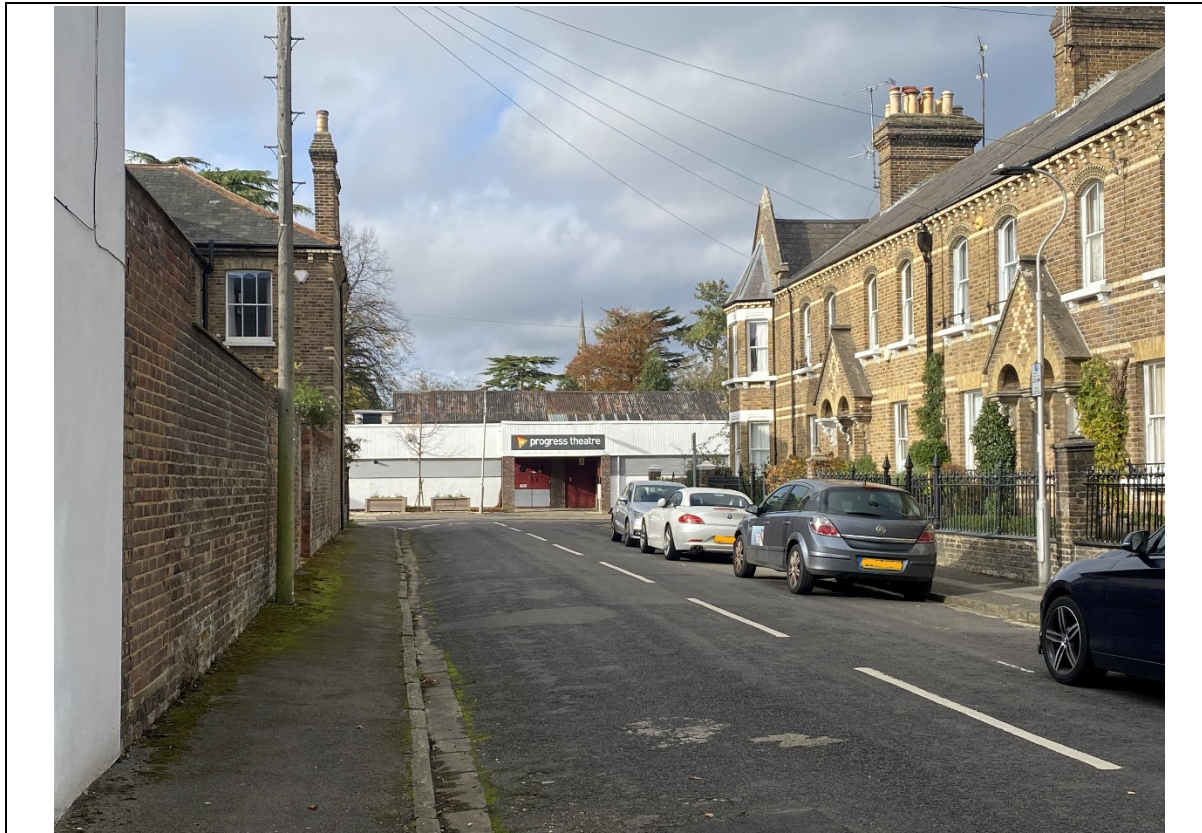
The Progress Theatre, founded in 1947, moved in 1950 from the W I Palmer Memorial Hall in West Street to new premises in The Mount which had formerly been the Mildmay Club, a working men's club founded in 1879 by Arthur Warwick Sutton which moved to the newly built hall in 1881, sufficiently large to hold 200 people. The hall has been enlarged in phases since its initial occupation, particularly after securing the freehold in 1964. The design of the main entrance façade onto The Mount dates from 1968.

Figure 21 The Progress Theatre today (Image Claire Truman)

The Progress Theatre has social and cultural importance whose origins are directly associated with the Sutton family. Its avant-garde design contributes substantially to the layers of history within the CA, and specifically to the setting of Character Area 1; every effort should be made to keep the property and the associated external spaces well maintained and managed.

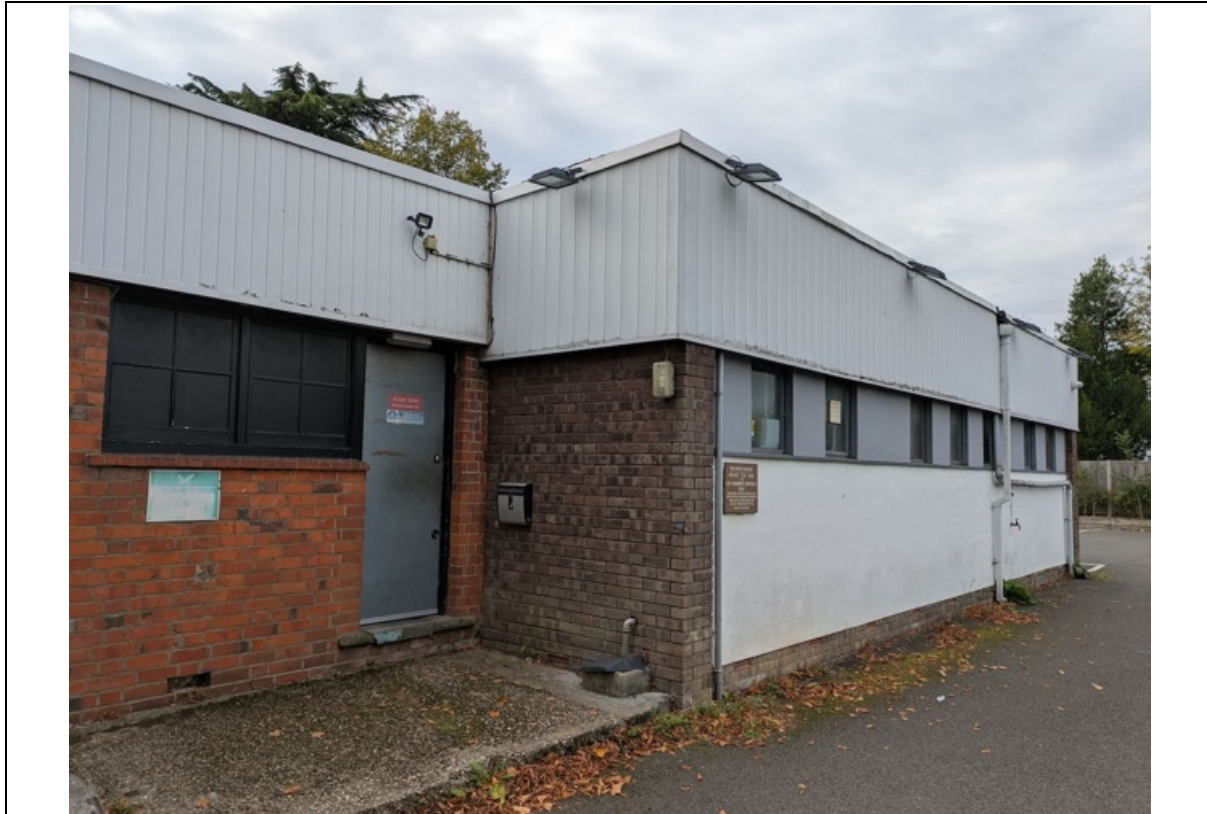
The Progress Theatre presents to the street a 1960’s style architecture and largely conceals the pitched roof of the original Mildmay Hall towards the rear. Whilst this is a contrasting style and use of materials, it adds another historic layer, not a competing one, to the CA.

Figure 22 The Progress Theatre today (Image courtesy Progress Theatre)
