BUILDINGS OF TOWNSCAPE MERIT

CHARACTER AREA 3

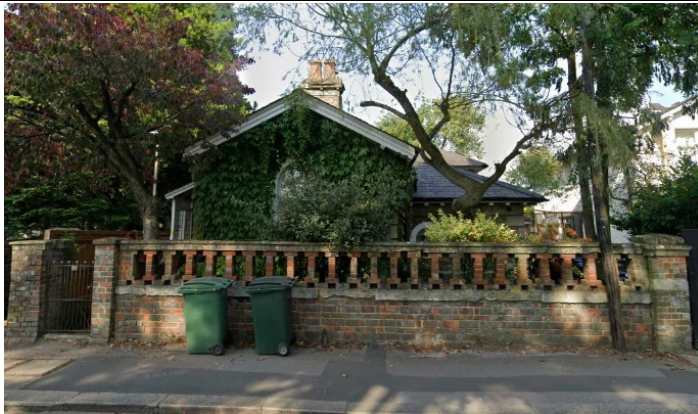
Address of Building	Image 1	Image 2	Comment
53 Christchurch Road

<p data-bbox="398 906 1093 933">Image from Google Maps September 2024</p>	  <p data-bbox="1115 1018 1774 1045">Image from end of 2025 (Image Evelyn Williams)</p>	Lodge building which adjoined the main entrance to “Sutherlands”, which site was redeveloped in the 1970s as Lancaster Close. Part of the original pierced and decorative wall remain

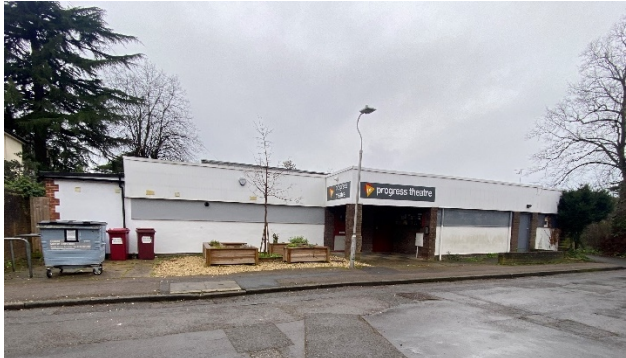
Address of Building	Image 1	Image 2	Comment
Progress Theatre

<p data-bbox="398 659 748 683">January 2025 (Image Claire Truman)</p>

<p data-bbox="1111 711 1487 735">November 2025 (Image Claire Truman)</p>	<p data-bbox="1787 300 2047 1311">The theatre’s architectural composition and appearance demonstrates how it has evolved since its origins as a corrugated iron-clad meeting hall from 1881, and has been incrementally extended to its latest iteration: the 1960’s modernist envelope. The corrugated iron-clad structure is rare for Reading. It has strongly contributed to Reading’s cultural and social development with notable nationally important figures visiting in the past.</p>
