# The Mount Conservation Area

## Conservation Area Appraisal

Draft V6.0

## **The Mount Conservation Area, Reading**

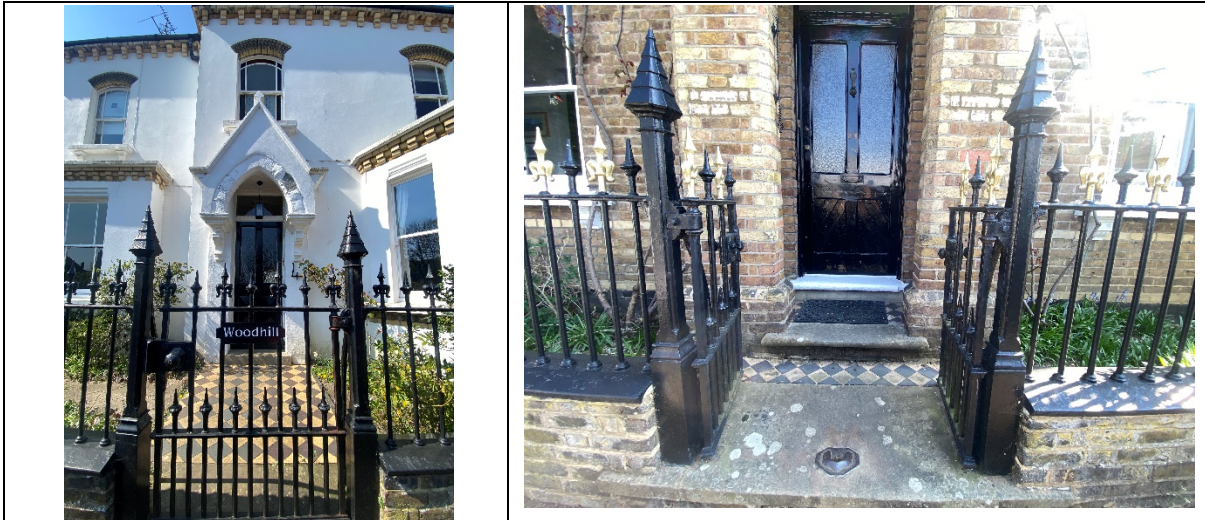
Brick walls and railings are to be found throughout the area and are clearly an essential part of the public realm and character of the CA. The cast iron railing design across the CA is consistently of a fleur-de-lys style. No.6 has lost its double leaf gate: it was one of what was 4 pairs. The other three, at No.s 8 and 22 (opposing pairs) and No. 24 (opposing pair to No.6) remain. It is notable that where the railings have been well maintained and repaired these create a positive enhancement to the wholistic character of the CA. The repair and re-painting of railings is encouraged; conversely, there is a conflict between enlarged tree roots that threaten the integrity and retention of historic railings at the corner of No.59 Christchurch Road (refer to Figure 26B).

*Figure 12 (Left) Single leaf gate at No.4 – also at No.s 10, 12, 14, 16, 18, 20, 23, 25, 38, 40 and side gates to No. 40 and 57 as a reflected pair. (Right) Figure 13 Double leaf gate at No. 24; and opposing detached houses No.s 22 and 8.*

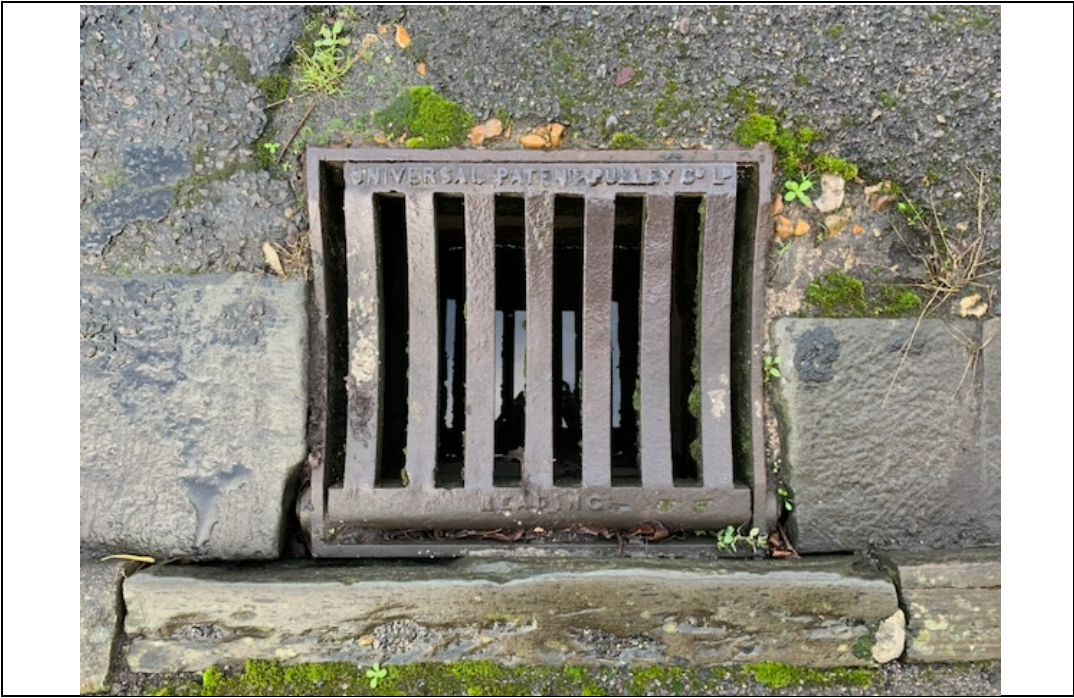
Original drain covers can be found in The Mount. Reading Ironworks went into liquidation in 1888 and in the same year The Universal Patent Pulley Co Ltd acquired the patent for the Universal Wrought Iron Split Pulley and manufactured it on part of the former ironworks. They also produced castings using the patterns from Reading Ironworks (Mercury 8 September 1888). The company was wound up in 1894.

Figure 13 Universal Patent Pulley Co drain set within 'Caithness Flagstone Series' gutter and kerb stones (Image Evelyn Williams)

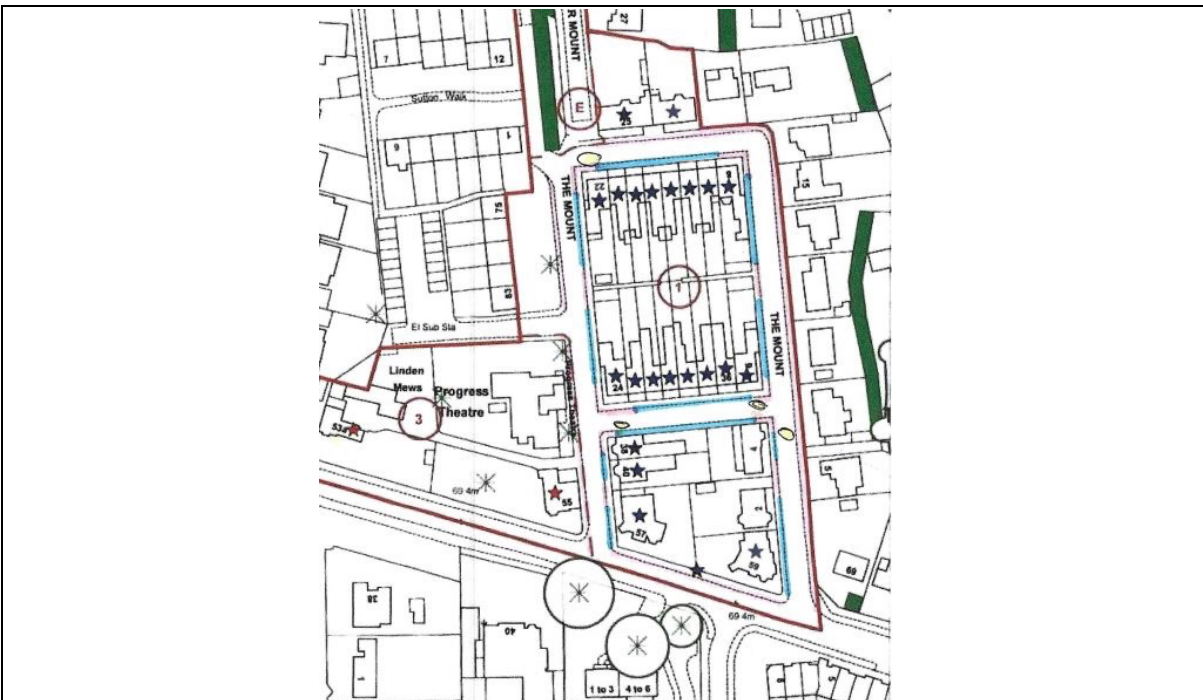
Road and footway surfaces are a mixture of finishes: the original kerbs and channels are a distinctive local detail of the stone 'Caithness Flagstone Series' of stone – only found elsewhere in Reading in Fatherson Road (adjacent to the Eldon Road Conservation Area); iron drain covers are partially retained and were manufactured in nearby Katesgrove (refer to section 5.4.2 below); the surfaces are tarmac.

Figure 14 Diagram of location of stone (blue) and concrete (pink) kerbs, and original ironworks (circles) at The Mount (compiled by local resident)

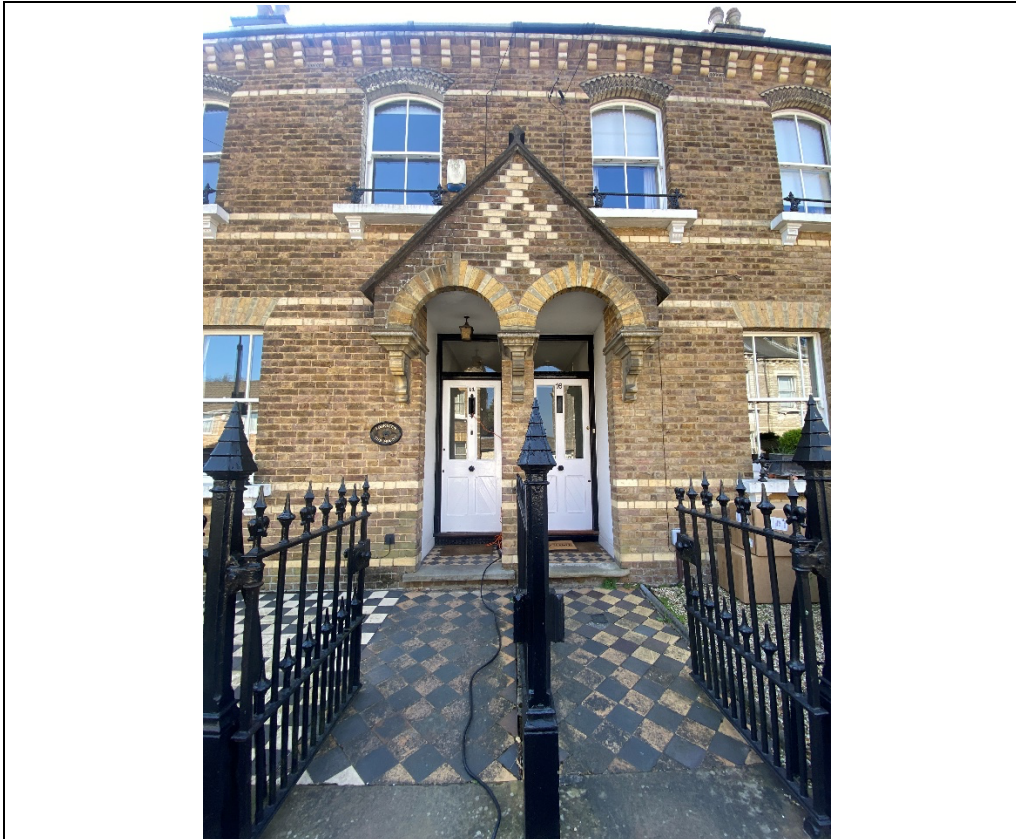
- prominent brick chimneys with dogtooth brick course details;
- fleur-de-lys railing design on a low brick wall.

*Figure 16 Unifying architectural details (Image Claire Truman)*

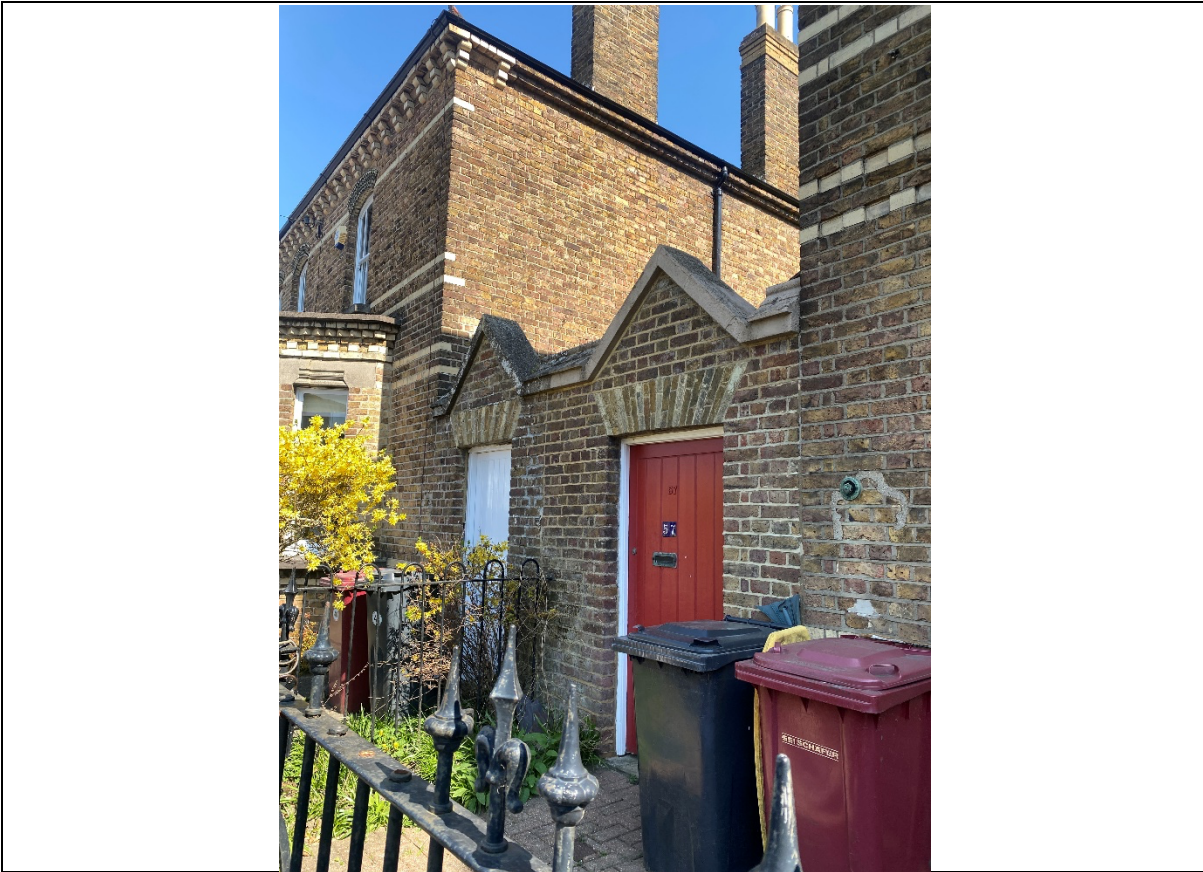
- Unifying walls between properties – such as the enclosing wall with paired garden access between No.s 57 and 40 (refer to Figure 17) illustrate the wholistic urban design.
- The consistent brick band details are located at the same height across the north and south 'blocks' despite the fall in gradient north-south along the road, and internal level changes between rooms and between properties. In particular the band detail carried through between No.6 and No.8 (refer to Figure 18) remains consistent yet the internal floor levels of the two properties differ in their relationship with the banding.
- The unifying architectural details, as listed on the previous page.

*Figure 17 Unifying urban design (Image Claire Truman)*

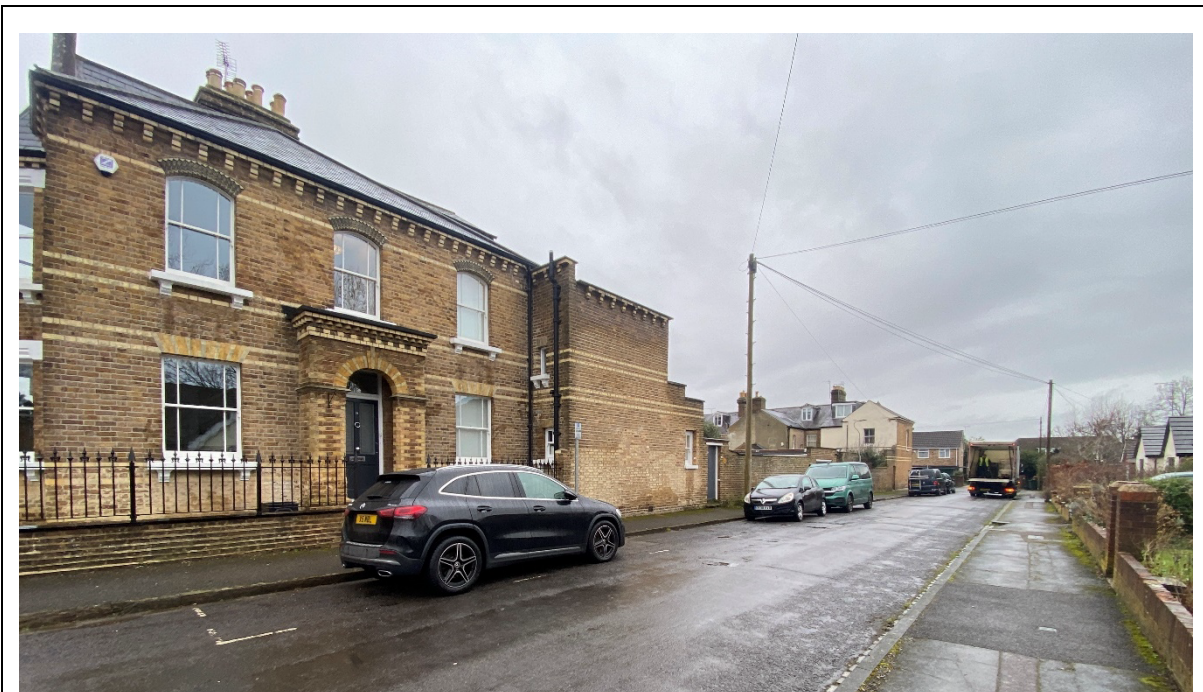
*Figure 18 Unifying yellow brick bands between properties in the north-south road directions (Image Claire Truman)*

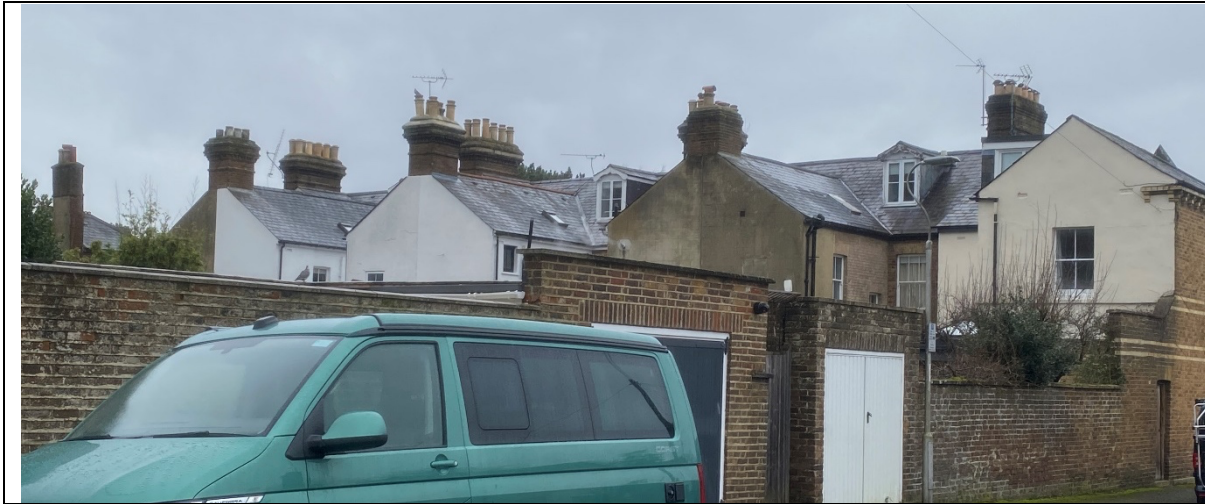
The two groups of terraced houses share these unifying architectural details which subtly obscure differences between them: the north terrace has a third 'attic' floor with original dormer windows whereas the south terrace properties have roof lights that align with the roof, however both terraces appear the same from the street elevation.

Figure 19 Original dormer windows to the rear of the north terrace of The Mount

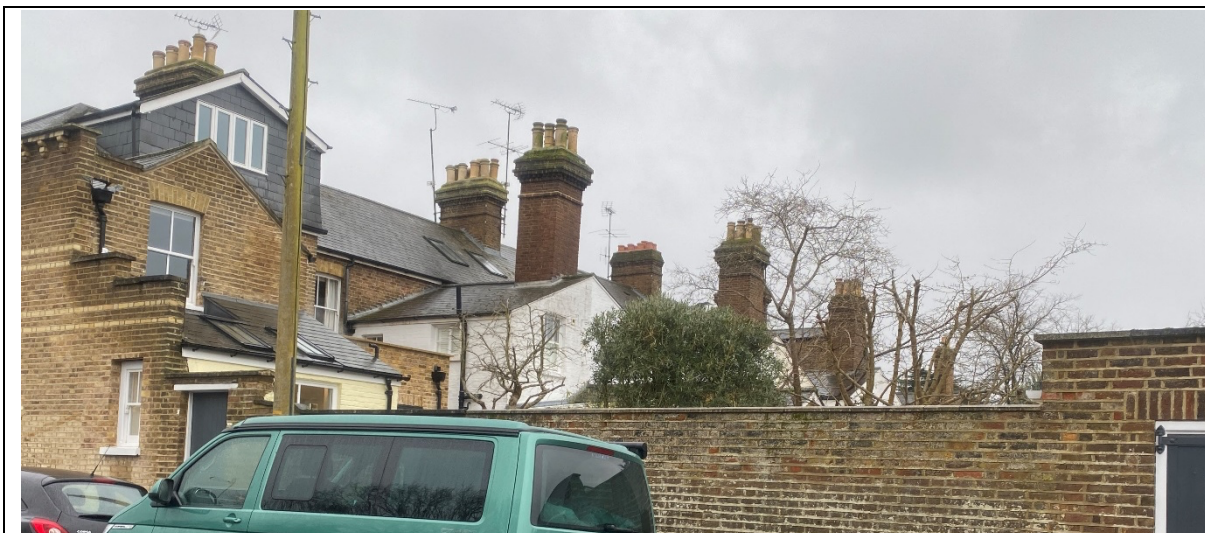
Figure 20 Roof lights to the rear of the south terrace of The Mount

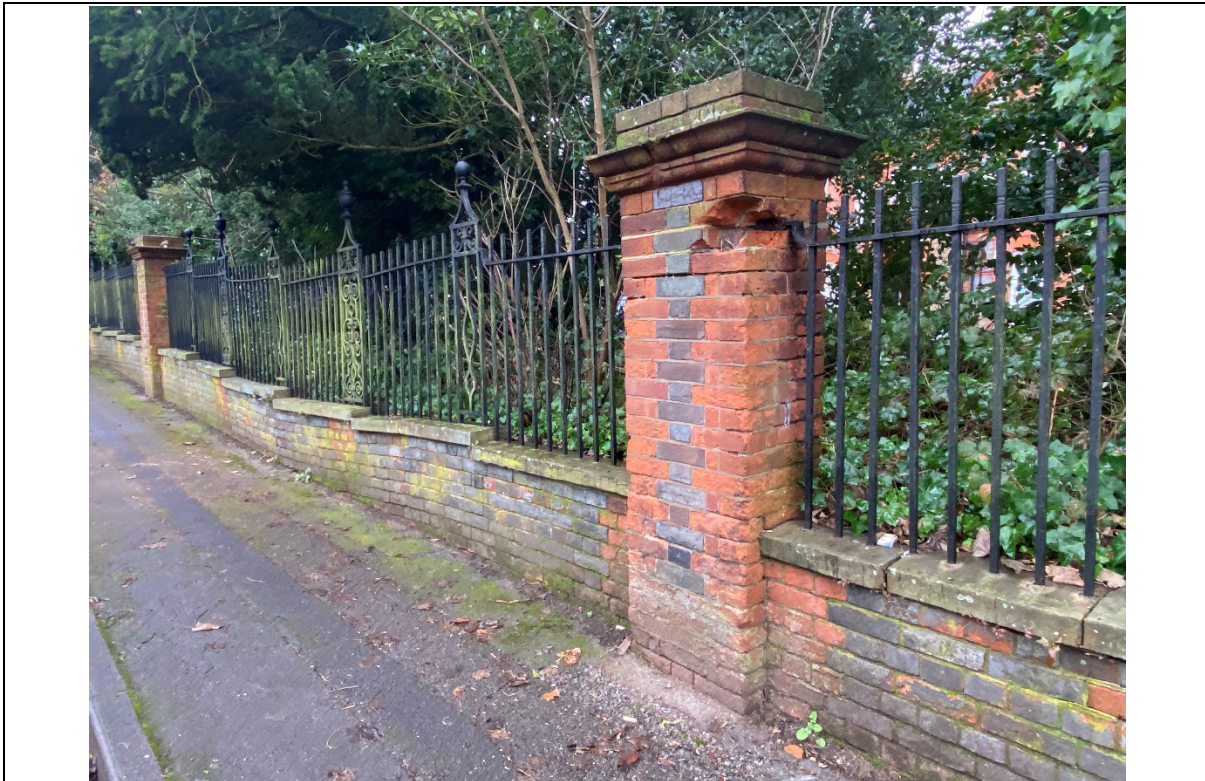
*Figure 22 The brick piers and railings to Hillside are falling into disrepair – view along Lower Mount (Image Claire Truman)*

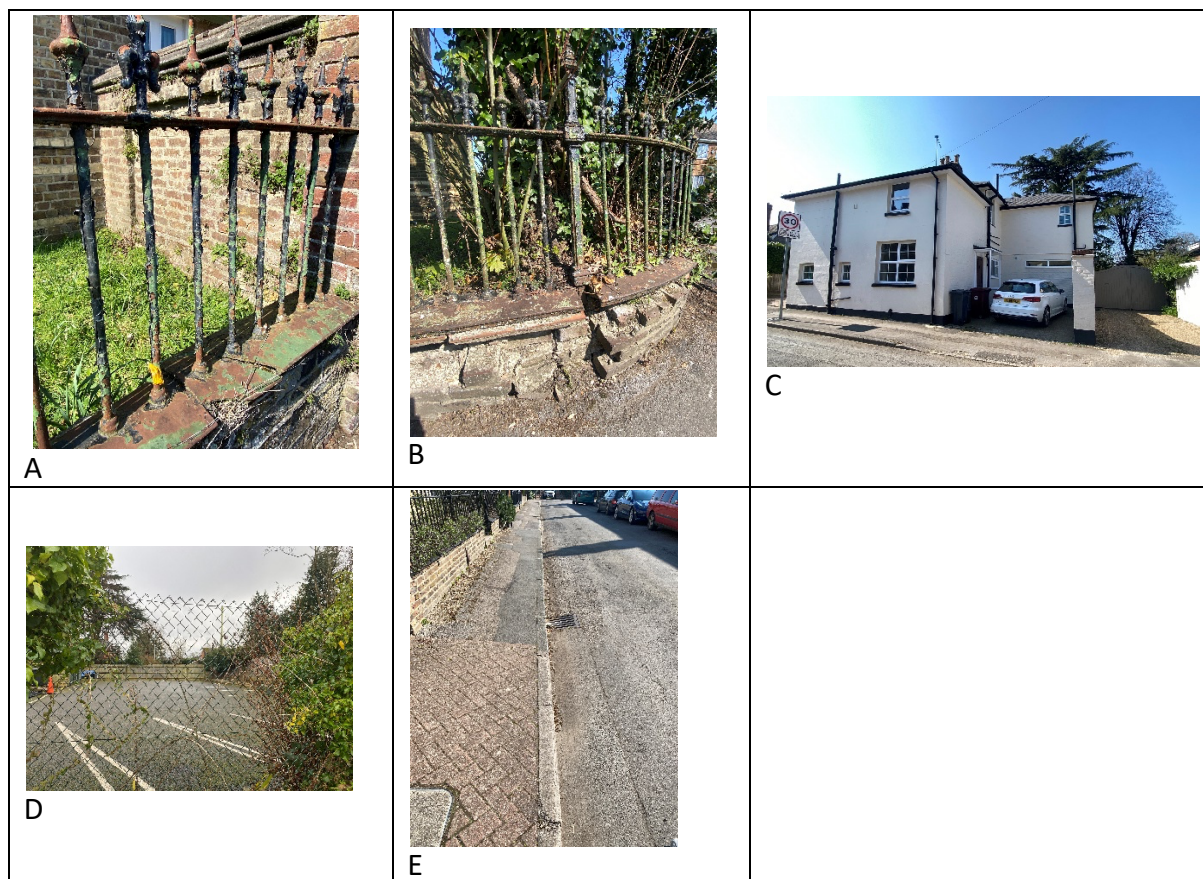
Figure 26 Images of loss or deterioration of details (Images Claire Truman)

- A – Deteriorating railings
- B – Deteriorating low brick wall and railings
- C – uPVC windows to building of townscape merit
- D – Chain link fence with unmanaged vegetation forming boundary of CA
- E – Pavements and kerbs a ‘patchwork’ of finishes

For unlisted buildings it is recommended that an Article 4 direction is considered to remove permitted development rights within the CA or parts thereof and prevent further erosion of the special character and appearance of the area. The management plan (Table 2) sets out to remedy some of these issues.

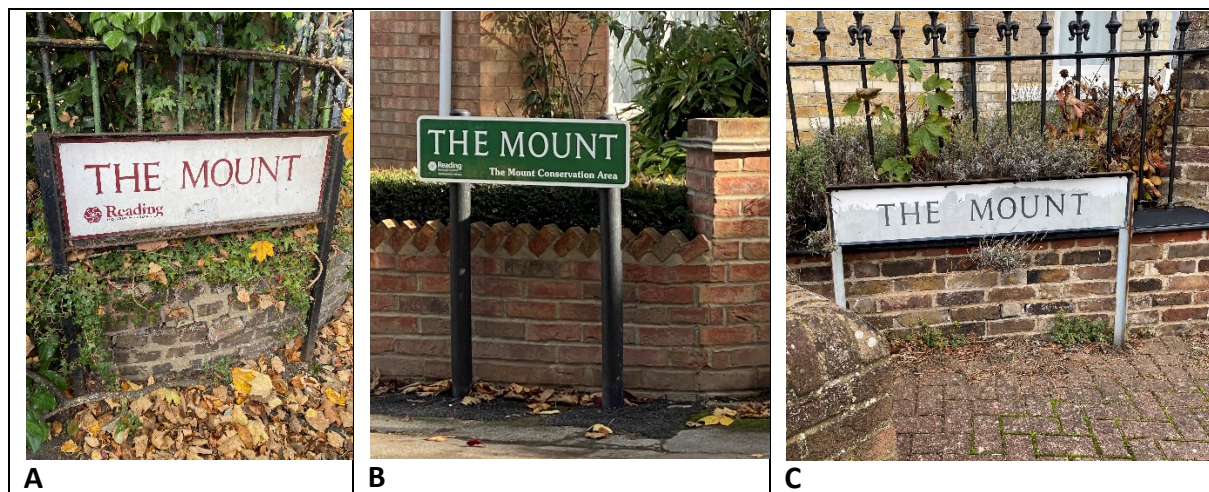
Inconsistent street signage for 'The Mount': three different types are in-situ – refer to *Figure 27*, below. *Figure 27B* shows the current design consistent to Reading's conservation areas.

*Figure 27 Images of three different conservation area signage styles (Images Claire Truman)*

Inconsistent ‘conservation area’ styled street signage (section 7.2.1).	<b>Awareness:</b> Replace superseded signage design with current design to achieve consistency within The Mount and across Reading’s conservation areas.	RBC
